Minimize Nail Pops

Form No. S300K

Revised June 2013

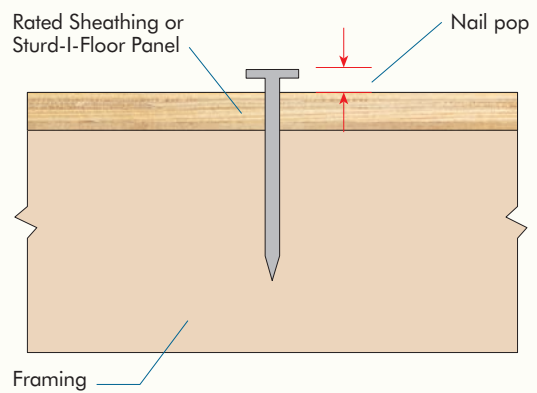
FIGURE 1
EXAMPLE OF NAIL POP

Nail “pop” or “backout” describes the protrusion of nail heads above the surface some time after they were originally driven into the wood (Figure 1). This sometimes happens when green (wet) lumber shrinks because of drying. The nail point stays put while the lumber shrinks along the shank, exposing the nail head.

Repeated wetting and drying of the wood may also cause “cumulative pop” (the nail backs out of the wood incrementally). Staples can also “pop” or “backout” under these conditions.

Tip 1: Choose the correct materials. Use dry lumber or engineered wood framing such as I-joists, trusses, glulam, or structural composite lumber, which is manufactured in a dry condition. Remember that even kiln-dried lumber has enough water left in it to cause some shrinkage.

Tip 3: Reduce nail pop. Use of deformed-shank nails may help reduce cumulative pop. For fastening underlayment, APA recommends ring- or screw-shank nails.
