Cladding Attachments Put to the Test

Testing for Leakage Under Extreme Water and Wind

Water penetration testing of cladding attachment fasteners through DensElement™ Barrier System, Thin-Mil Fluid Applied, and Thick-Mil Fluid Applied Membranes at elevated air pressures and water exposure.

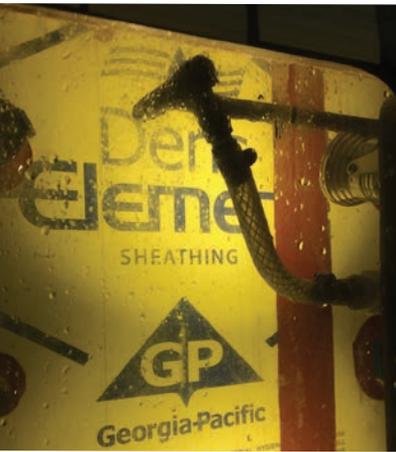
The DensElement™ Barrier System tested per ASTM E331

The test wall and water spray nozzles were set up per ASTM E331. The walls were then subjected to water spray duration and negative air pressure loads exceeding ASTM E331 protocol for code compliance.
